## Activity Completion Report: Northern Group Rainwater Harvesting Project

<b>Activity Title</b>	Northern Group Rainwater Harvesting Project
<b>Goal</b>	To improve resilience against natural disasters and public health by providing a reliable and safe water supply for the islands of Pukapuka, Nassau, Penrhyn and Rakahanga
<b>Intended outcomes</b>	<ol style="list-style-type: none"><li>1. Increased capacity for rainwater storage and collection</li><li>2. Improved resilience on these islands to natural disasters (including drought proofing)</li><li>3. Strengthened disaster management capabilities</li><li>4. Sustainable growth of opportunities for employment, improved public health and well being</li><li>5. Promotion of environmentally sustainable economic development</li></ol>

<b>Prepared by:</b>	Development Coordination Division
<b>Version #:</b>	10

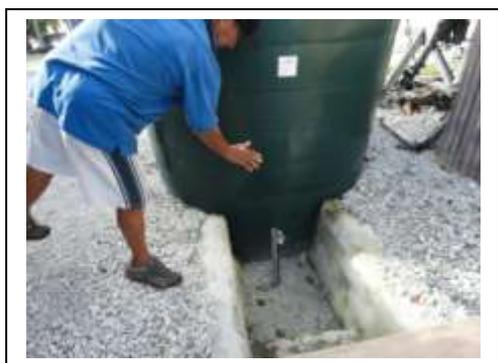
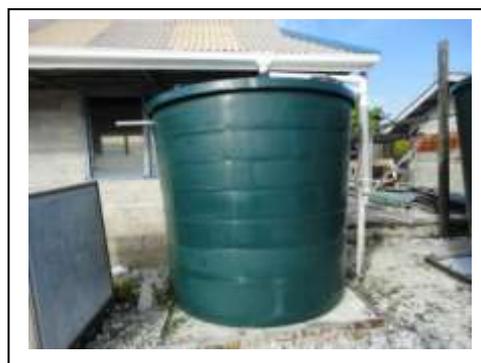
Partial **burial of water tanks** was an effective technique to reduce cost, increase stability of tanks and adapt to households with low roof overhang. Proving more resilient over time engineers recommended burial of tanks rather than installation on a sandy base. Since the original installation of the tanks, overflowing water when there are great deluges of rain has destabilised some tanks on a sandy base. It has been recommended that the next time the tank is dry, that the householder digs a shallow pit in which to sit the tank. Some homeowners have already done this (RD Report).

Tank sunk into the ground (by owner)    Tank on gravel/sand in a timber frame (Rakahanga).

The **burying of tanks** also proved cost-effective (\$850 as tendered engineered concrete base per versus 0) and reduced damage to the water tanks. The MOIP engineered design priced concrete bases would have costed \$240,000 for the whole project. The project manager, contractor and other key stakeholders developed the the local innovation to bury the tanks or place them on sand bases, which had no cost as home owners could contribute this effort. This local on-site innovation avoided creating a situation that could lead to tanks splitting as had sometimes occurred in the past when water tanks were placed on expensive concrete slabs. The burying of water tanks is another new norm that can be utilized to lower the cost of future rainwater harvesting projects.

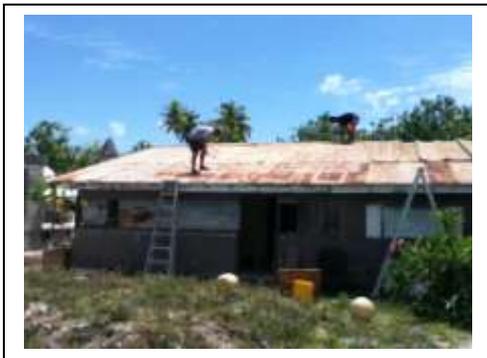
Roofing replacement - Before

(Rakahanga)

- Ideal roofing quality should be alumium 0.7mm which does not rust and resists peeling effect in cyclone conditions. Roof structures should be strengthened with cyclone ties and replacement of frames to ensure structural integrity.
