Client: **COOK ISLAND GOVERNMENT (MOIP / NZAP)**

Project: **NORTHERN GROUP WATER HARVESTING PROJECT**

Date: 10<sup>th</sup> – 28<sup>th</sup> October 2011

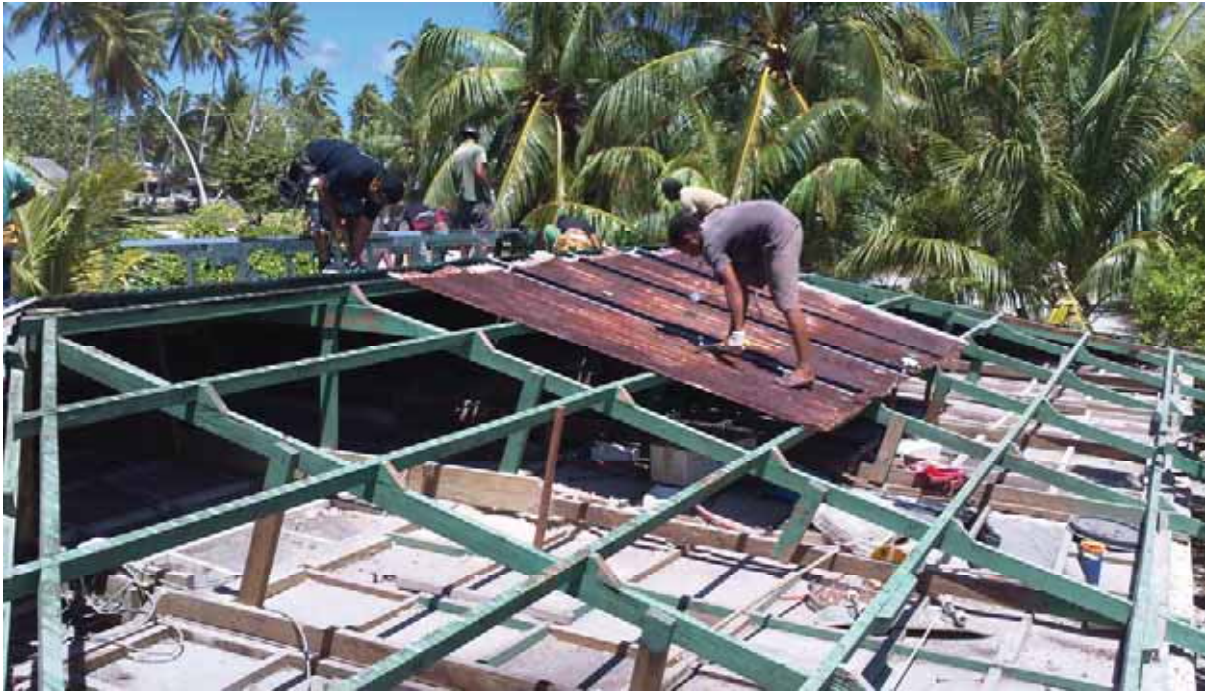
BEFORE

A total of 29 houses were fixed with new roofing. 15 were complete re-roofs, 9 houses had one side only fixed, 5 houses replaced roofing iron sheets only.

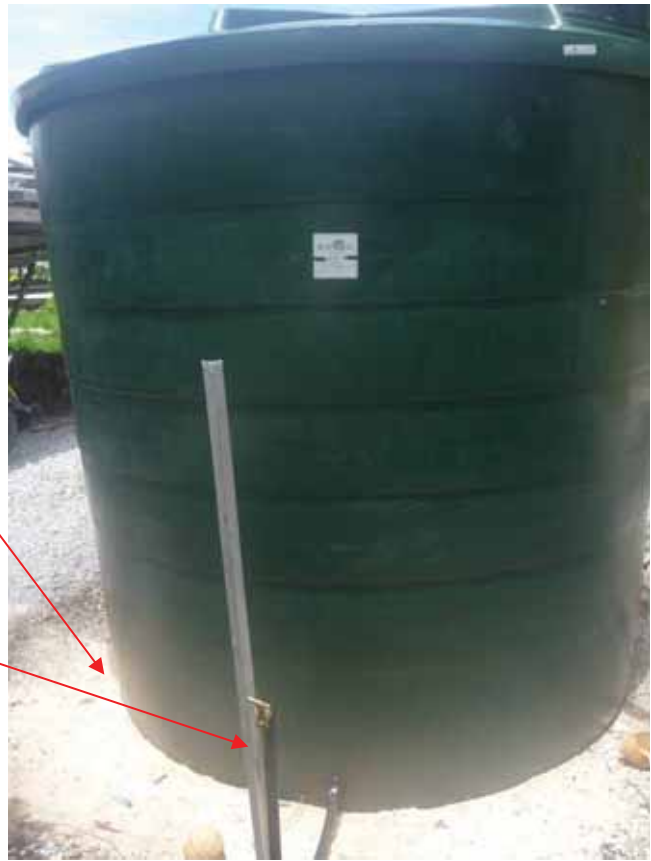
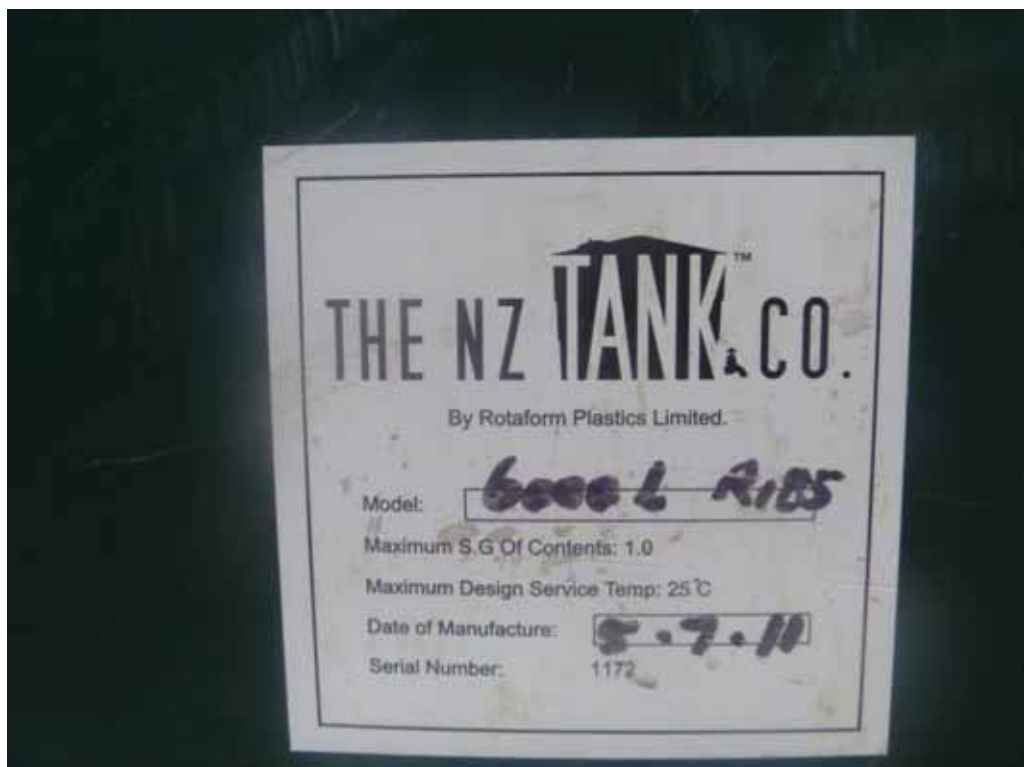
A large hole approximately 2.4m in diameter and 300mm provides the base course for the water tank. The base is then filled with 100-150mm of well-compacted sand (free of debris & stones). The tank is then placed into the hole and back-filled with remaining sand. Water outlet is positioned to the preference of the homeowner. Final fit-out of piping for tap is then complete with galvanized steel stand approximately 400mm from ground level. *Note that all ground surfaces vary and the location and placement of each tanks is considered specifically for each household.*

SERIAL NUMBERS FOR EACH TANK & SHOWING DATE OF MANUFACTURE

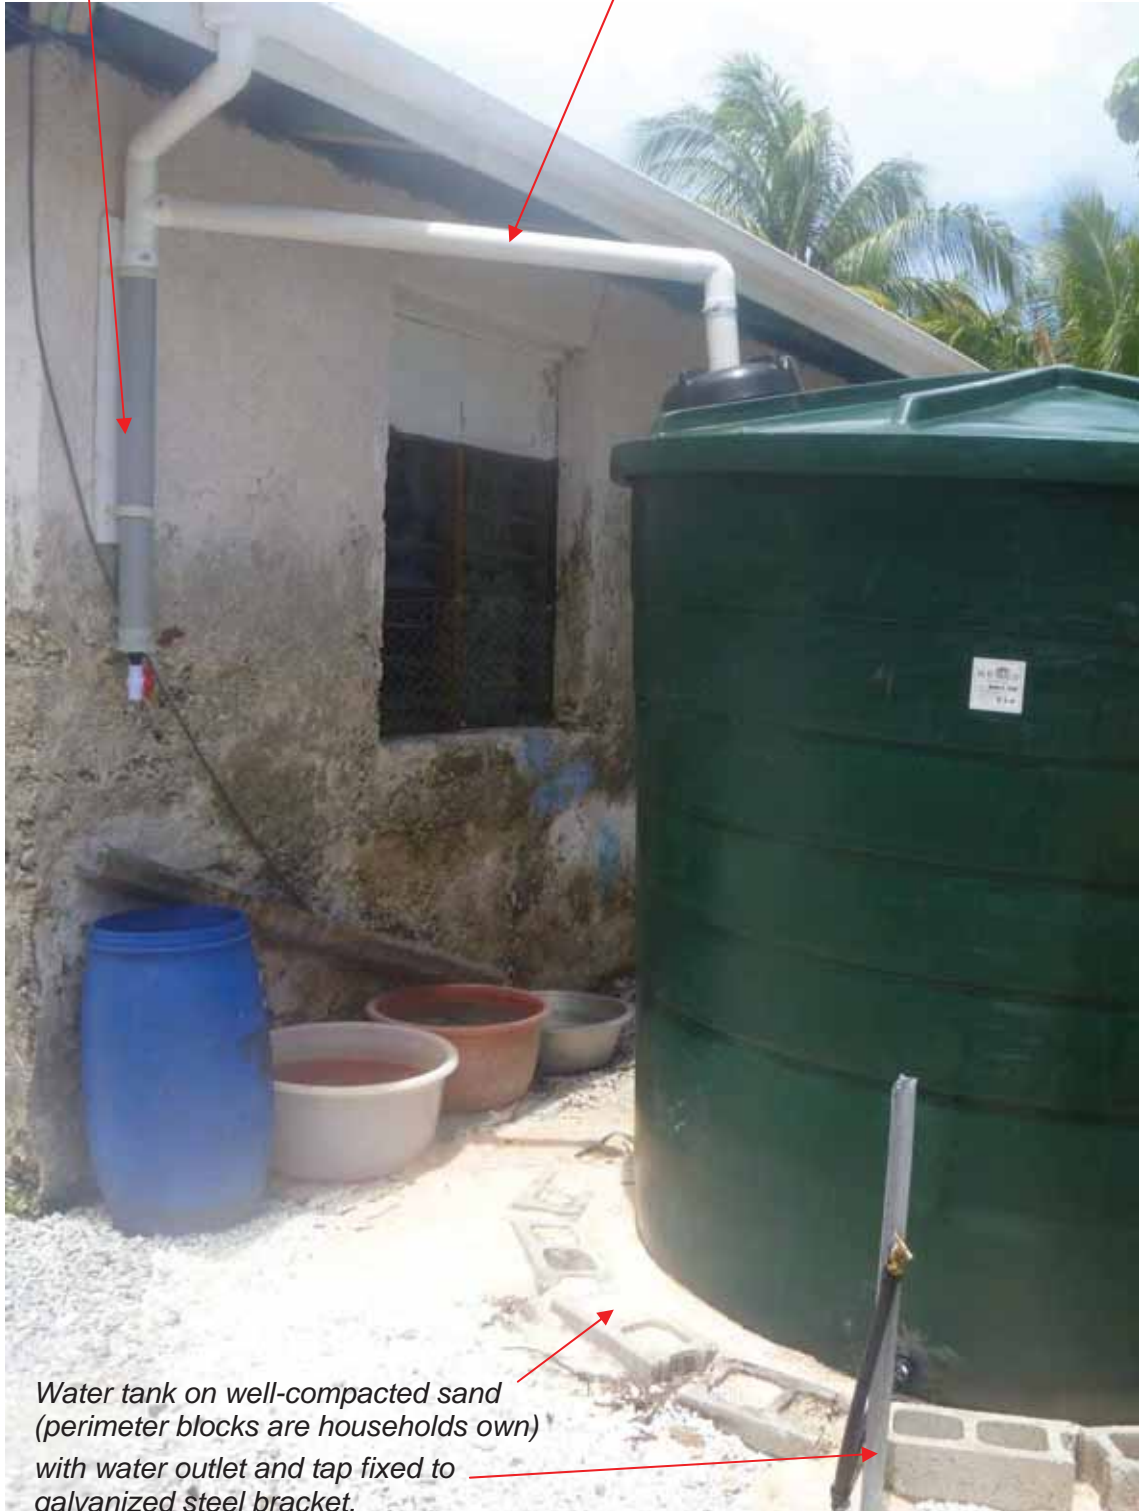
*Complete Water Collection System installed:*

*New roofing iron, fascia board and spouting (to one side only) with dropper into diverter;*

*1. first flush system straight down into empty drums*

*2. downpipe to water tank inlet at top.*

*Note: heights of water tanks are relative to the height of eaves of each house*

*Water tank on well-compacted sand  
(perimeter blocks are households own)  
with water outlet and tap fixed to  
galvanized steel bracket.*
